**CITY OF TAKOMA PARK  
7500 MAPLE AVENUE  
TAKOMA PARK, MD 20912**

**PHASE I ENVIRONMENTAL  
SITE ASSESSMENT**

**TAKOMA JUNCTION REDEVELOPMENT  
TAKOMA PARK, MARYLAND**

**November 2012**

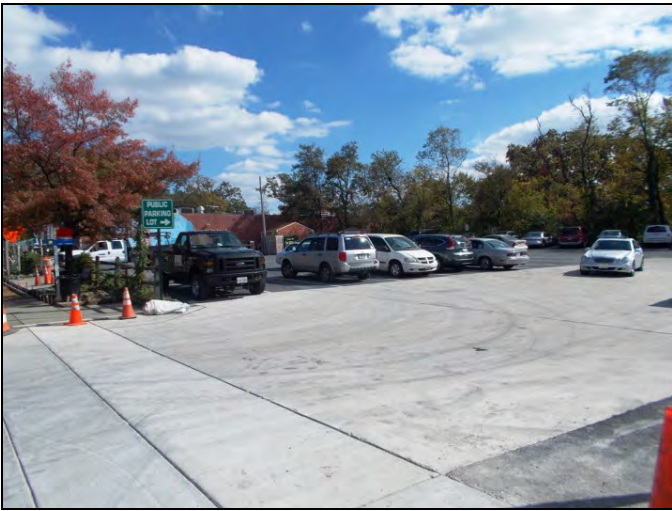
**Takoma Junction subject area:** The north side of the property, with public parking lot and one entrance from Carroll Avenue, including the concrete pad that had been used for the temporary fire station.

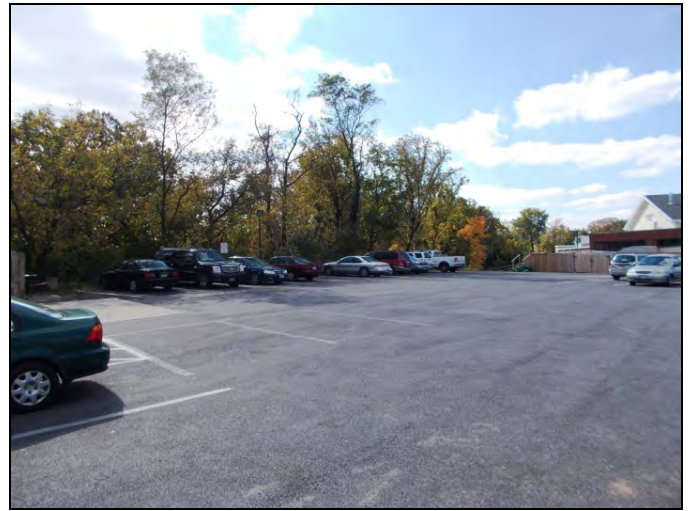
**Takoma Junction subject area:** The center of the property, with public parking lot.

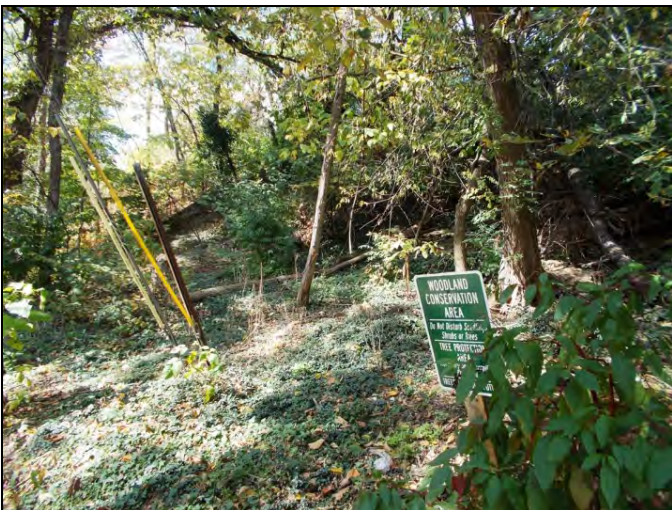
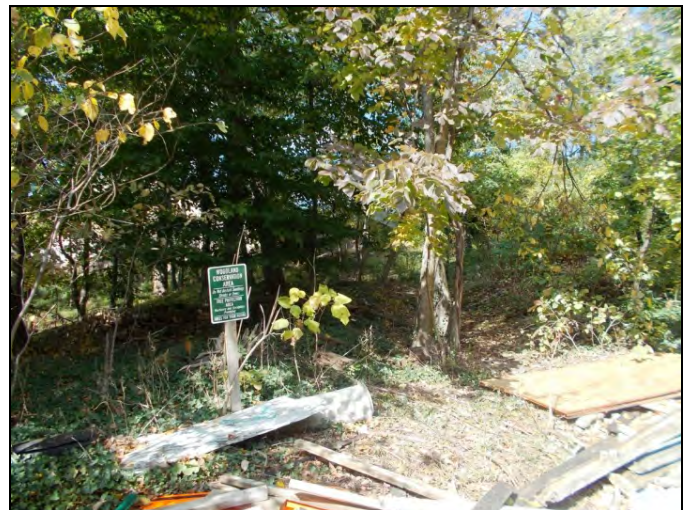
**Takoma Junction subject area:** The south side of the property, consisting of woods and undergrowth in a Takoma Park Woodland Conservation Area.

The woods on the south side of the subject area were observed to be thickly vegetated, with a variety of ground-cover bushes that hampered views of the soil condition. No RECs were observed.

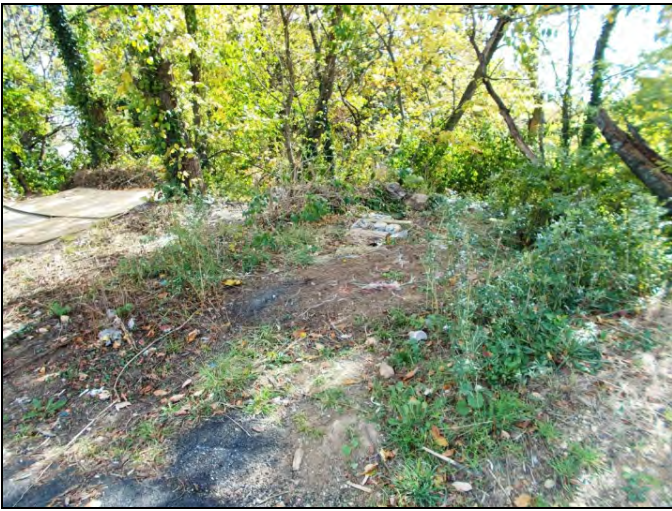
**Takoma Junction subject area:** The south edge of the parking lot, with litter and debris disposed along the top of the slope down to the wooded side of the property.

- The southern part of the subject area's parking lot had been the site of commercial trash and rubble dumping over several decades. The dumped material included commercial waste. Some people familiar with the site also believe that the wooded area probably contains rubbish and trash in the soil fill. The nature and extent of the waste dumped on-site is unknown.
- There is evidence that minor dumping continues to the south and east of the subject area's parking lot, including visible stained soil and solid waste.

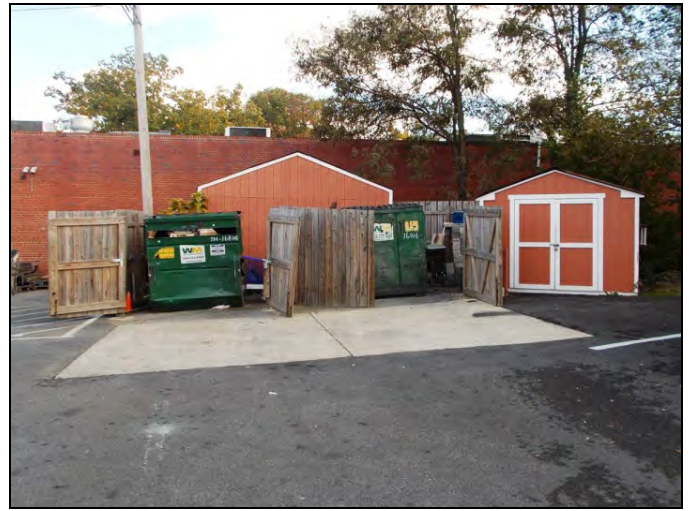
**Takoma Junction subject area:** The east side of the property, where the TPSS Co-op has placed two storage sheds and two trash receptacles.

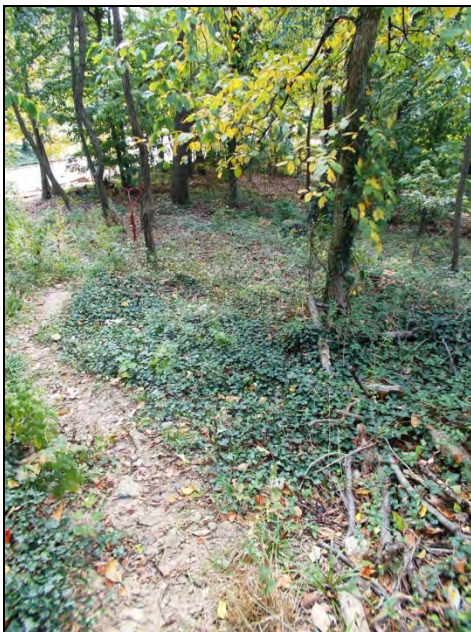
**Takoma Junction subject area:** The south corner of the property, with a steep, informal footpath running from the corner of Columbia and Poplar Avenues to the parking lot.

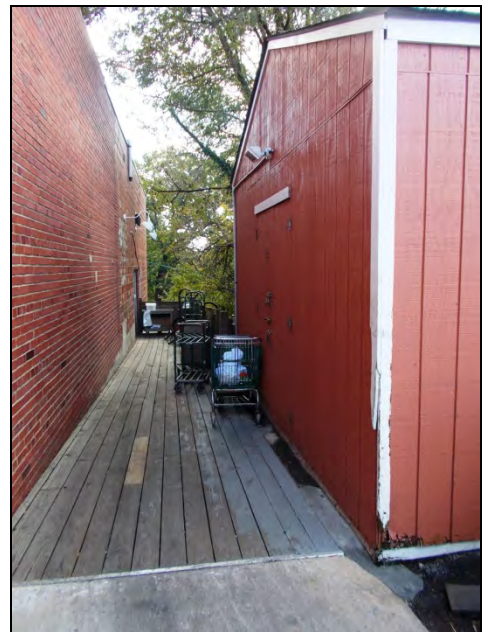
**Takoma Junction subject area:** The east side of the property, with an access ramp to the TPSS Co-op's back entrance and locked large storage shed.

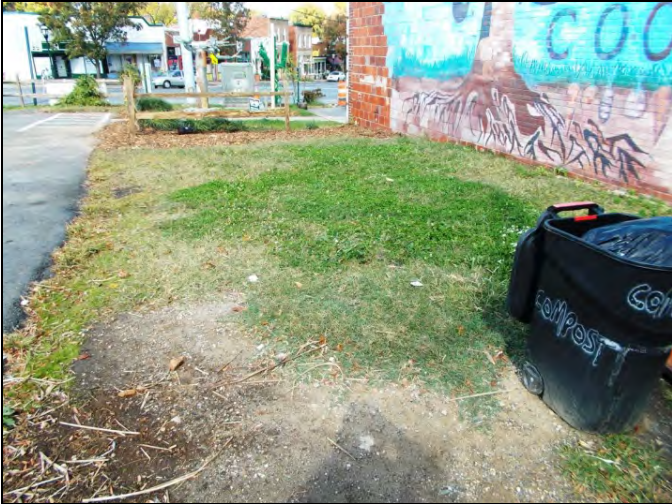
**Takoma Junction subject area:** The east side of the property, with an unpaved grassy area next to the TPSS Co-op and minor soil staining.

The asphalt parking lot at the subject area appeared to be in good condition, with no significant cracking and only very minor staining from leaked vehicle fluids. Concrete pads for the storage sheds near the southeast corner, and for the prior temporary fire station near the northwest corner were observed to be in good condition. Trash and other debris were partially visible on the hillside south of the parking lot, but the vegetation appeared to have overgrown most signs of the debris. Very dark stains and dead grasses were on patches of the soil to the south of the parking lot and also on the strip of lawn on the east side of the subject area, adjacent to the TPSS (Co-op). Such surface contamination is an REC to the subject area.

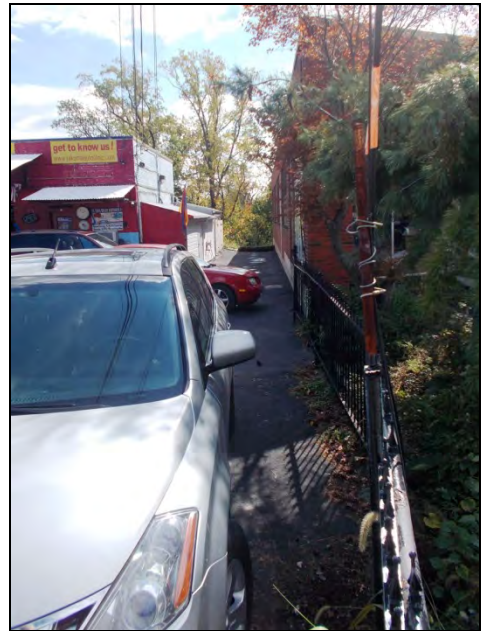
**Takoma Junction subject area:** The separate 10-foot right-of-way between 7221 (on the left) and 7211 Carroll Avenue (on the right), paved and fenced in by Takoma Auto Clinic.

The 10-foot right-of-way between 7221 and 7211 Carroll Avenue, separate from the main section of the subject area, was observed to have asphalt pavement throughout and to have straw bales at the south edge of the property for surface water flow.

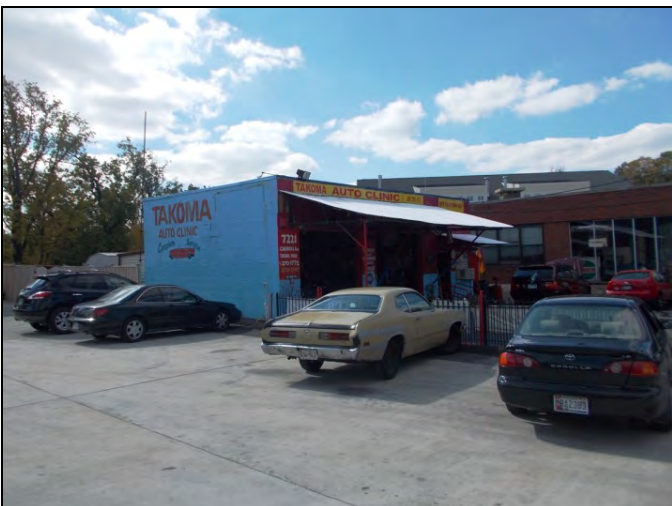
**Takoma Auto Clinic:** 7221 Carroll Avenue, on the northwest side of the subject area, and Healey Surgeons at 7211 Carroll Avenue in the background.

**7221 Carroll Avenue** – The Dawes family began a trash business in 1956, C. Dawes & Sons Trash Company, operating for approximately 30 years. As partially described in *Section 5.1 Standard Environmental Record Sources*, in 1990, this property was found to have petroleum products leaking from USTs. Six USTs were removed and disposed of off-site (five gasoline, one waste oil) in 1990. Adjacent contaminated soil was also removed. Some residual contamination remained under the tanks, however; MDE did not consider the levels sufficiently high to warrant soil removal. In 1994, this property was purchased by the Takoma Auto Clinic.

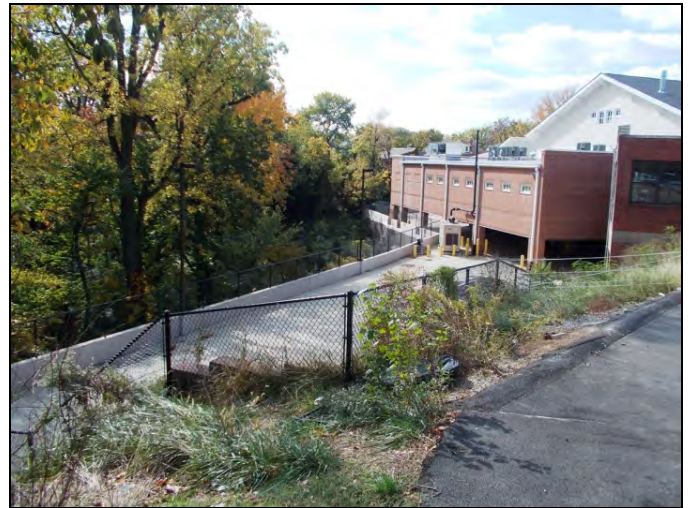
**Takoma Park Volunteer Fire Department:**  
The rear of the newly renovated facility, as seen from the subject area's parking lot. The woods in the left background is part of the subject area's undeveloped property.

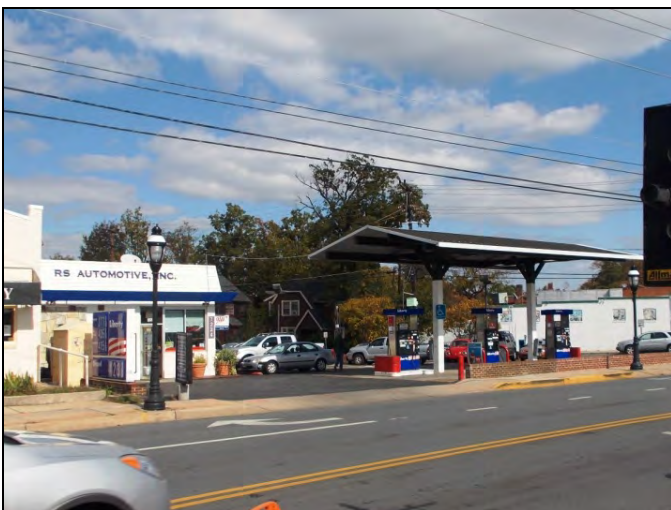
**7224 Carroll Avenue (Property D)** – RS Automotive, Inc. and Takoma Junction Liberty gas station is an automotive service and repair shop with one island of six gasoline pumps along Carroll Avenue. Currently the station has three underground storage tanks (USTs) with a combined capacity of 30,000 gallons.

**RS Automotive and Takoma Park Liberty gas station:** Opposite the subject area, on the north side of Carroll Avenue.

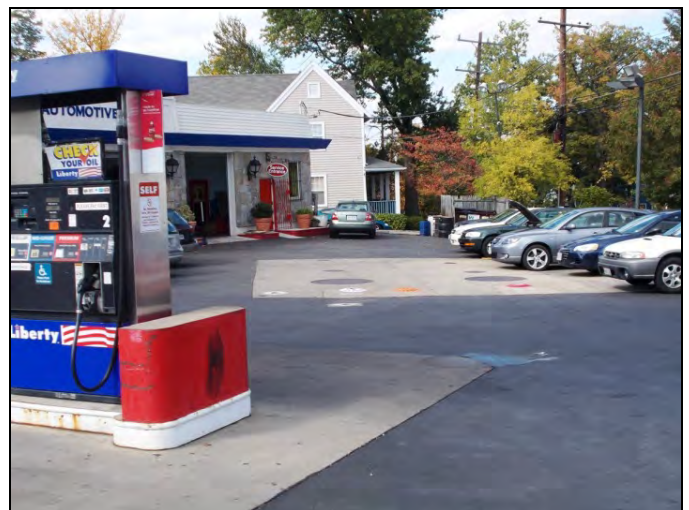
**RS Automotive and Takoma Park Liberty gas station:** The gas pumps on the left and the underground storage tanks on the right, in the background, on the northern side of the property.

**7224 Carroll Avenue** – As partially described in *Section 5.1 Standard Environmental Record Sources*, contamination was discovered at this gas station in the late 1980s. Substantial remedial activity subsequently took place under the supervision of MDE, including removal of 11 USTs (including one fuel oil tank by Carroll Avenue), excavating and disposing of contaminated soil from fuel oil and waste oil tankpits, and installation of product recovery wells and monitoring wells. Following remediation, MDE noted that residual contamination remained in the soil; however, the levels were not high enough to be of concern. The operations at this location were inspected in 2002 and 2009 and failed in several areas. Following implementation of remedial action, the station passed inspection in March 2010.

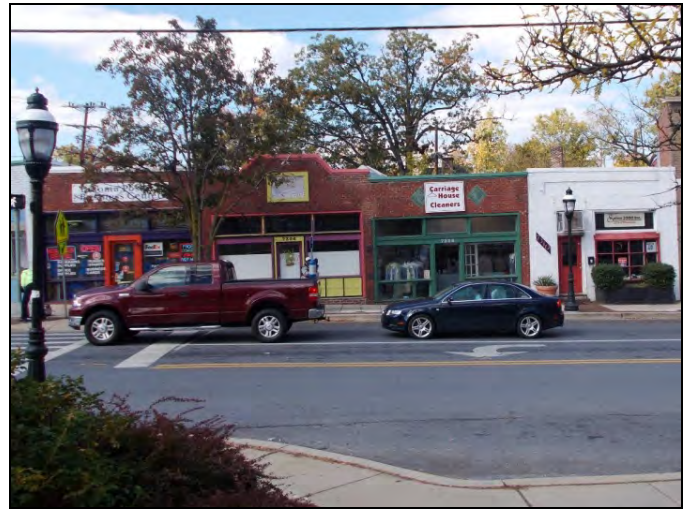
**7300-7308 Carroll Avenue:** Small private businesses north of the subject area, including Carriage House Cleaners at 7308 Carroll Avenue.

2009 found hazardous substances including PCE, vinyl chloride, acetone, cis-1,2-dichloroethene (DCE), trichloroethene (TCE), ethylbenzene, naphthalene, xylenes, and isopropylbenzene in the soil, soil vapor, indoor air, and/or groundwater. The source of the contaminants is not currently known, however, they are common constituents of dry-cleaning activities and gasoline. MDE considers the PCE and TCE contamination the most problematic and has set clean-up goals for these materials.

In 2011, the property owner submitted a response action plan (RAP) to MDE for on-site remedial work. The owner proposed to remediate the contamination by installing a depressurization system under the foundational slabs at 7306 and 7308 Carroll Avenue; no remediation is required at 7300, 7302 or 7304 Carroll Avenue. This system would pump volatile vapors from the soils under the slab and release it into the ambient air. Sampling at the property would occur periodically until the clean-up goals for TCE and PCE have been reached. The RAP was approved by MDE on November 21, 2011, with implementation to begin within 60 days. Periodic vapor samples would be measured. Concurrently with the clean-up, MDE has required a further off-site investigation of groundwater near the site in the direction of migration of the chemical plume, which is toward Lee Avenue, to the northeast.
